SERVICE INSTRUCTION

DATE:	August 15, 1986
SUBJECT:	Engine Timing Marks
MODELS AFFECTED:	All Avco Lycoming Direct Drive Engines
TIME OF COMPLIANCE:	Each 100 hour inspection.

Service Instruction No. 1437 Engineering Aspects are FAA Approved

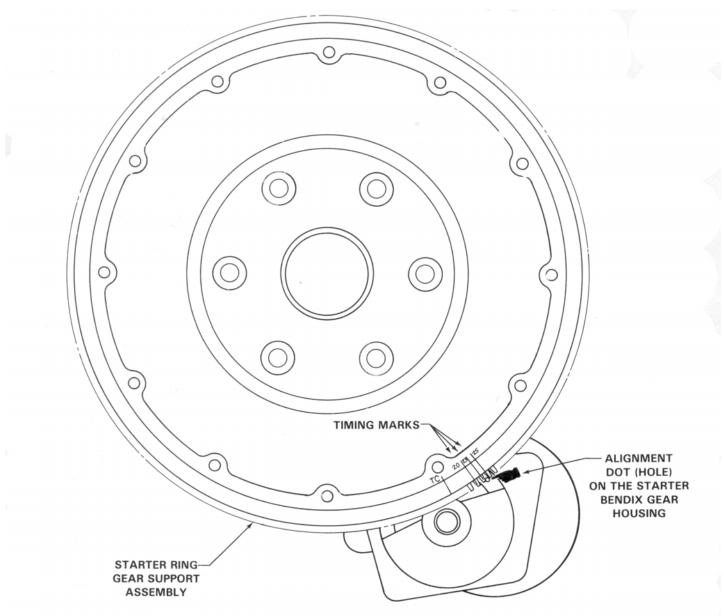
Figure 1. Correct Alignment of Advance Timing Marks with Starter Housing

In addition, a further inspection should be made to determine that the alignment is still correct as manufactured by making sure the starter ring gear is still in it's original installed position and has not moved on the ring gear support. See Figure 1. During assembly, the identification mark "O" on the front face of the starter support assembly is lined up with the identification mark "O" on the crankshaft face. See Figure 3.

MARKS ON THE RING GEAR AND SUPPORT HOUSING SHOULD BE IN ALIGNMENT. IF THESE MARKS ARE NOT IN ALIGNMENT. IT CAN BE DETERMINED THAT THE RING GEAR HAS MOVED ON THE SUPPORT HOUSING AND THE ENTIRE ASSEMBLY MUST BE REPLACED BEFORE RE-TIMING THE ENGINE.

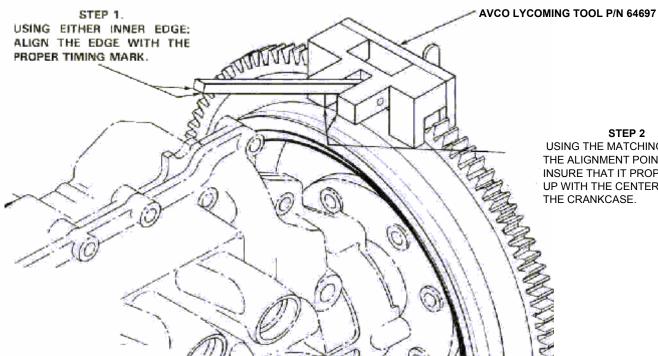
Figure 2. Use of Avco Lycoming Tool P/N 64697

The second method requires bringing the No. 1 cylinder into the compression stroke in the same manner as in the first method. Then clamp the ignition timing pointer (Avco Lycoming Tool P/N 64697) on the appropriate advance timing mark on the back face of the starter ring gear support as shown in Figure 2. Continue rotating the crankshaft until the ignition timing pointer and the split line of the two crankcase halves align. Leave the crankshaft in this position until the magneto timing has been checked and any corrections to the timing have been made.

STEP 2 USING THE MATCHING EDGE OF THE ALIGNMENT POINTER, INSURE THAT IT PROPERLY LINES UP WITH THE CENTER LINE OF THE CRANKCASE.

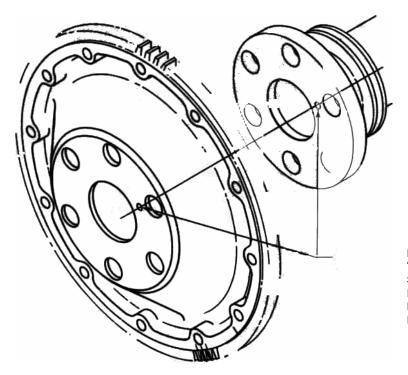
Figure 3. Alignment of Identification Marks at Assembly

IDENTIFICATION MARK "O" ON THE FRONT FACE OF THE STARTER SUPPORT ASSEMBLY IS LINED UP WITH IDENTIFICATION MARK "O" ON THE CRANKSHAFT FACE DURING ASSEMBLY
