**CONTINENTAL MOTORS® AIRCRAFT ENGINE
CRITICAL SERVICE BULLETIN
COMPLIANCE NECESSARY TO MAINTAIN SAFETY**

**CATEGORY 2
CSB08-3C**

SUBJECT: Throttle and Mixture Control Levers

PURPOSE: Remove bronze control levers from service

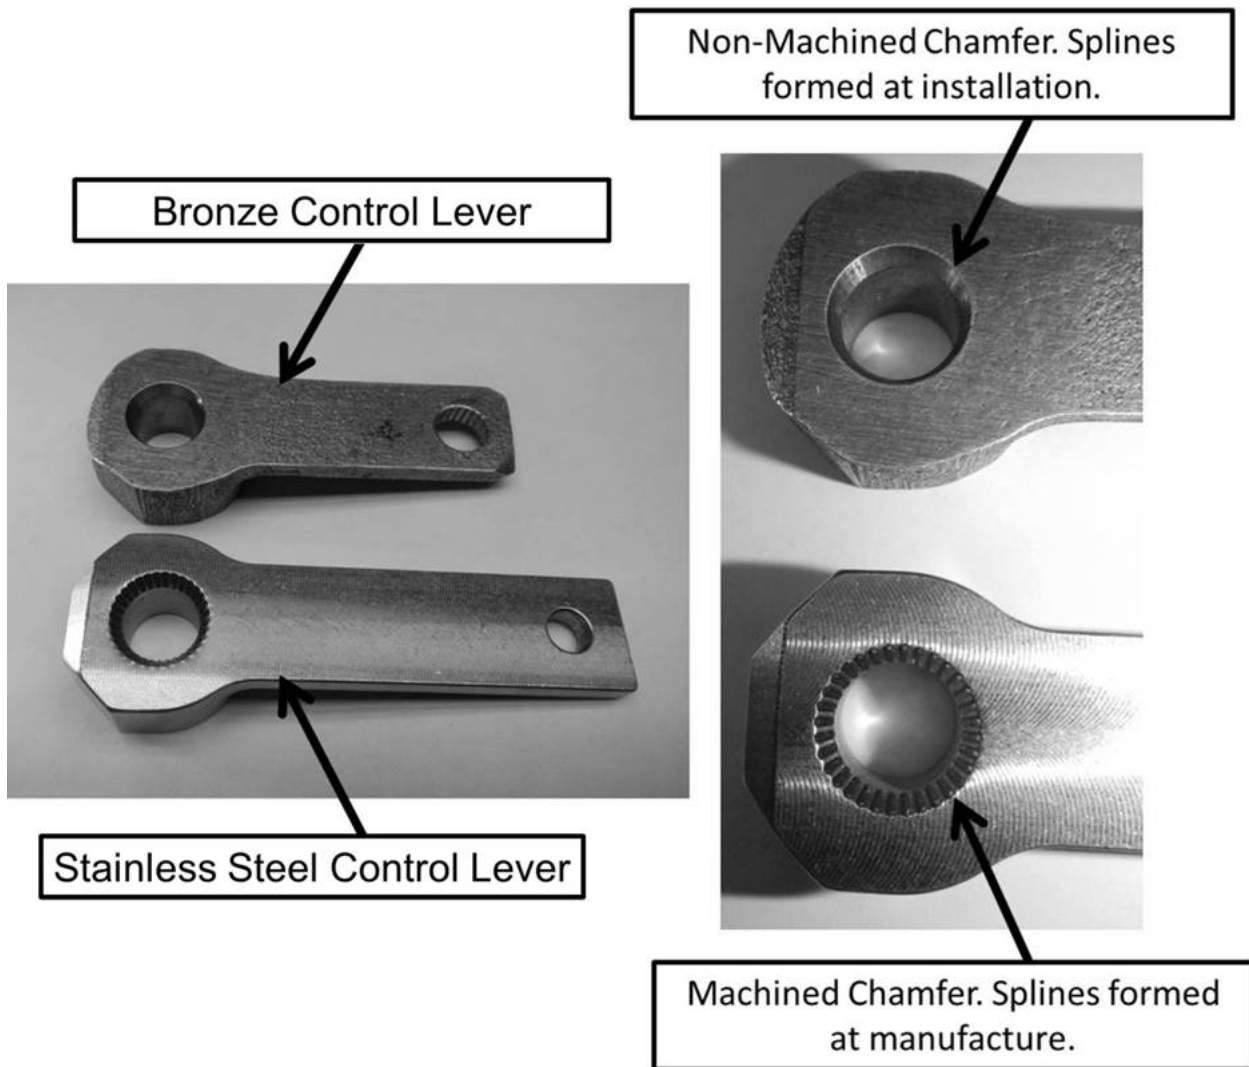
Figure 1. Throttle and Control Lever Identification

1. Original control levers designed for threaded shafts were manufactured from a bronze material and featured a non-machined (smooth) female chamfer on one side, which mated to the machined splined male chamfer on the throttle and mixture control shafts.
2. The replacement control levers are manufactured from stainless steel and feature a machined (splined) female chamfer, which interlocks with the machined splined male chamfer on the throttle and mixture control shafts (Refer to Figure 1 for control lever identification).
3. In addition to the levers mentioned in the paragraphs above, certain installations utilize bronze levers that are secured to the shaft with a steel pin. This bulletin does not address those installations. Refer to the applicable periodic inspection intervals in the engine Maintenance and/or Overhaul Manual.

CMI is aware that some bronze control levers were improperly installed on threaded shafts in the field, and the mechanical interlock was absent. Therefore, as part of our ongoing quality interests:

All bronze control levers on threaded shafts of Continental Motors fuel injection systems must be REMOVED and REPLACED with stainless steel control levers during the next 100-hour or annual inspection or at the time a throttle or mixture control lever is removed for any reason, whichever occurs first.

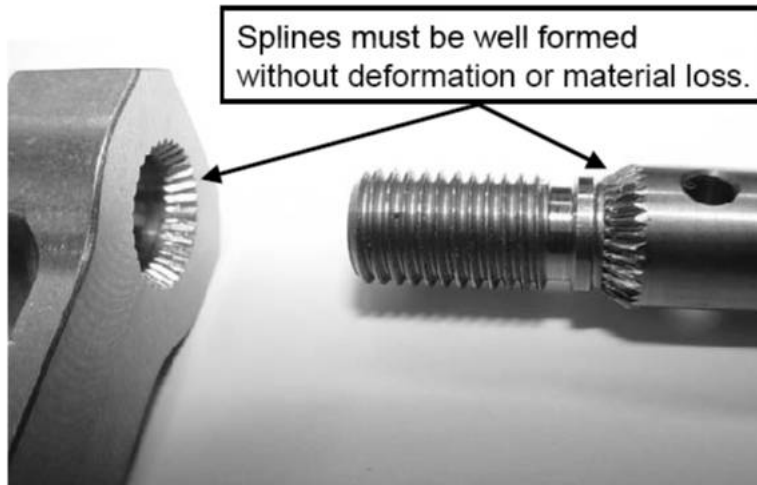
Figure 2. New Stainless Steel Control Lever and Shaft

1. Inspect the component's shaft and the NEW stainless steel control lever to ensure no damaged or stripped threads exist and that the splines are well formed and without deformation or material loss (See Figure 2).

2. Install the current style, stainless steel control lever onto the component shaft, positioning the lever to allow for proper airframe control interface (consult the Airframe Manufacturer's adjustment instructions).

3. Ensure that the splines in the control lever chamfer are meshed with the splines on the component shaft (see NOTE: above)
4. Lightly lubricate the control shaft threads with clean 50-weight engine oil.
5. Install and tighten a NEW retention lock nut on the shaft to secure the lever; rotate the lever away from the stop pin and torque the nut 100-120 inch-pounds.
6. Check the control lever after torque application to ensure there is no free play or movement of the control lever on the component shaft.
7. If free play or movement is felt after the nut is torqued to the correct value, remove the control lever and determine the cause for movement (if applicable, re-install the control lever and repeat steps 3 through 6 above. If lever continues to have free play after being torqued, replace the control lever).

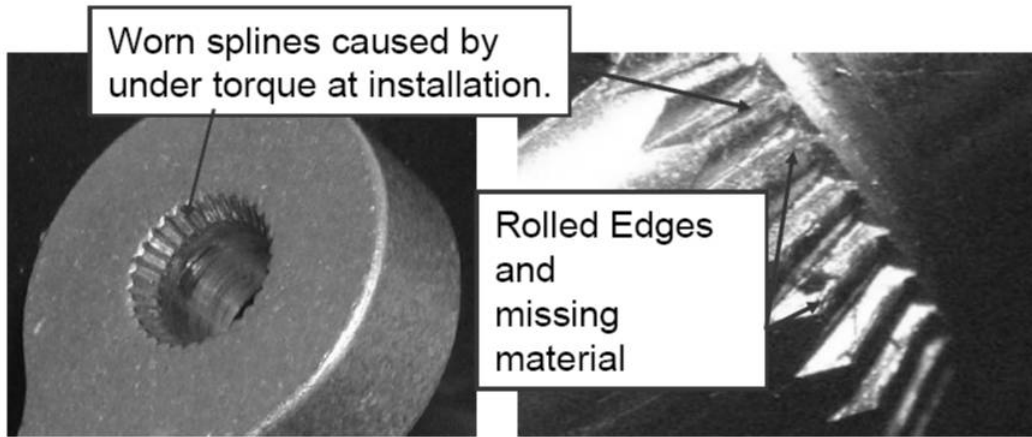
Figure 3. Control Lever and Shaft Spline Inspection

1. Verify the stainless steel throttle and/or mixture control levers are securely installed on the control shafts.
2. Inspect the installed lever(s) for looseness or free play on the shaft - looseness or free play of the lever on the shaft is prohibited.
3. Verify the retaining nut (if used) is torqued 100-120 inch-pounds.

Any control lever or shaft exhibiting damage must be replaced prior to further service using the procedures contained in the applicable Maintenance or Overhaul Manual and this Service Bulletin.
