**MANDATORY SERVICE BULLETIN****MSB18-08C**

- SUBJECT:** Inspection and Maintenance Modification of Cylinder Assemblies
- PURPOSE:** To inspect and remove casting material build-up on the radius edge of identified cross-flow cylinder heads.
- COMPLIANCE:** If under 500 hours in service, perform radius blend inspection and modification no later than the next scheduled 100-Hour/Annual inspection. If 500 hours or greater, perform radius blend modification at the next maintenance event (not to exceed 50 hours).
- MODELS**
- AFFECTED:** New and rebuilt Continental Aerospace Technologies GTSIO-520-C, D, H, K, L, M, N; IO-550-G, N, P, R; IOF-550-N, P, R; TSIO-520-BE; TSIO-550-A, B, C, E, G, K, N and TSIOF-550-D, J, K, P aviation gasoline (AvGas) engines originally manufactured, rebuilt, or modified with a cross-flow cylinder replacement on or after 01 NOV 2014.

**DOC NO REVISION PAGE**  
MSB18-08 C 1 of 10

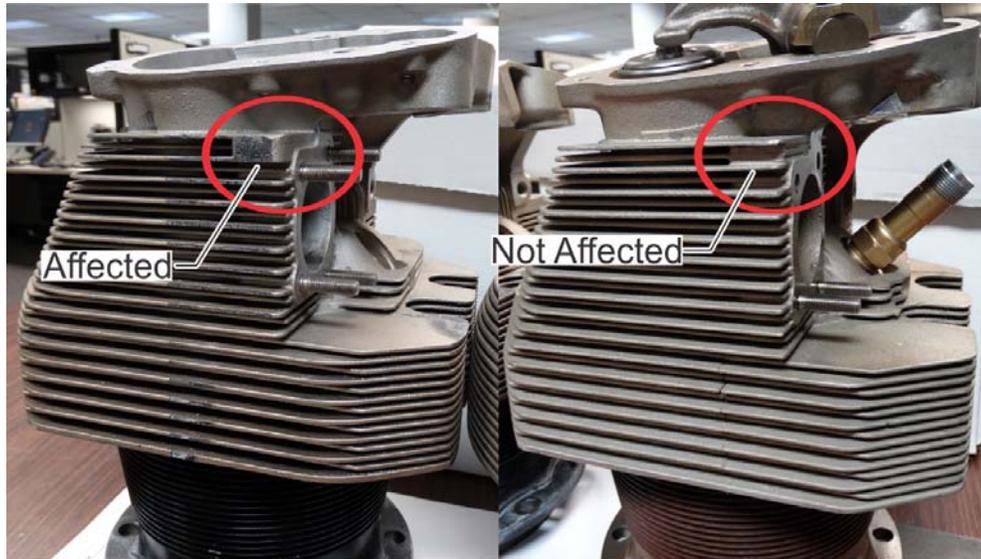
Several field reports indicate the potential for fracture initiation on engines (exceeding 500 hours of operation) at the radius edge of identified cylinder heads produced on or after 01 NOV 2014 (see Figure 3). The affected cylinder casting can be identified by the “filled” top fin flange area above the exhaust port as shown in Figure 1.

Affected cylinder head castings have a distinguishing feature (see Figure 1) from unaffected. Affected new and rebuilt engines with serial number 1036883 and later were inspected and corrected at the factory to comply with this Service Document.

Figure 1. Affected Cross Flow Cylinders, Top Fin Flange typical

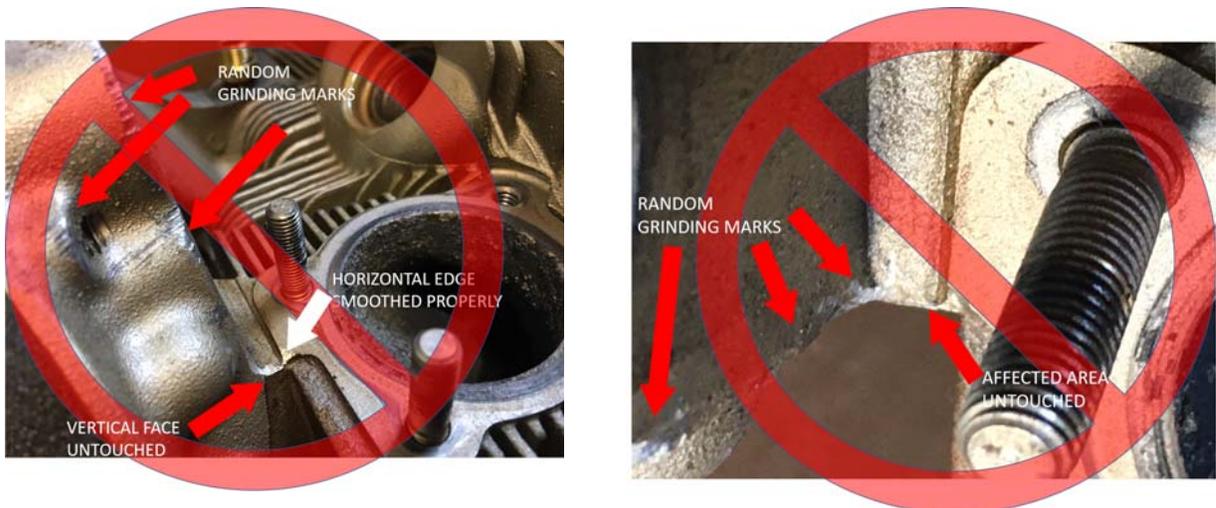
Figure 2. Examples of Non-Compliance

*Incomplete Rework with Grinding Marks on Unaffected Area*

*Grinding Marks Evident but Affected Area Untouched*

Examples in this section illustrate unacceptable attempts to perform the modifications intended to meet the requirements. The preferred tool to accomplish the modification is a short (6" to 8") bastard file; it is very effective for smoothing the affected outside corner and is easier to control in tight spaces than a power tool, such as a die grinder.

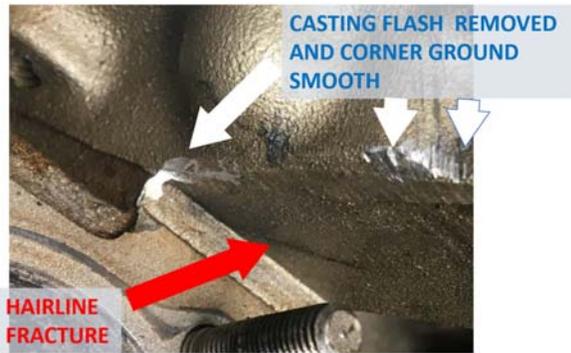
The photos below are from a cylinder removed for oil seepage at 802 hours. The log book entry for compliance with SB18-08 was 798 hours. The red arrow in the photo points to the hairline fracture already existing in the affected inspection area at the time compliance was recorded.

Rework performed on cracked cylinder

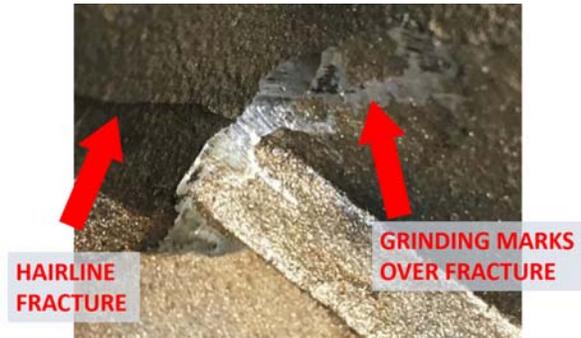
grinding marks through crack - closeup

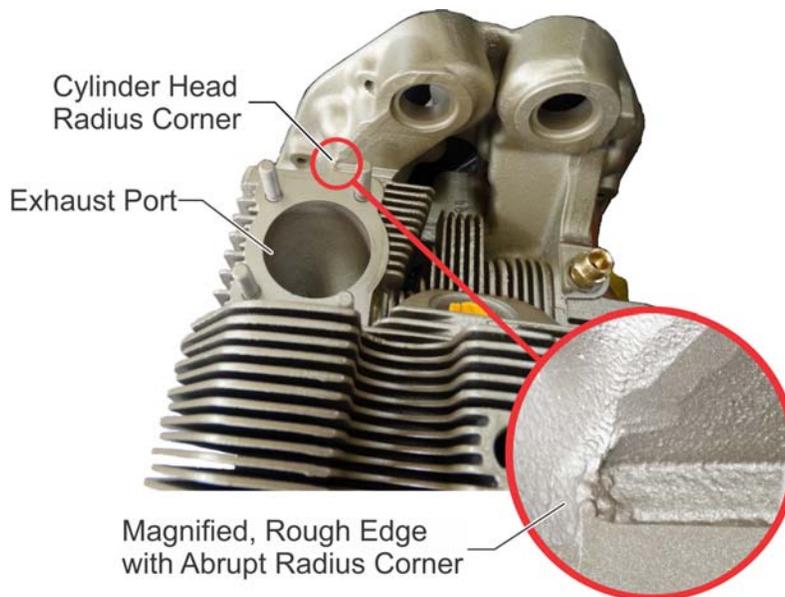
Figure 3. Abrupt Radius Edge with Flash Material Build-up, typical

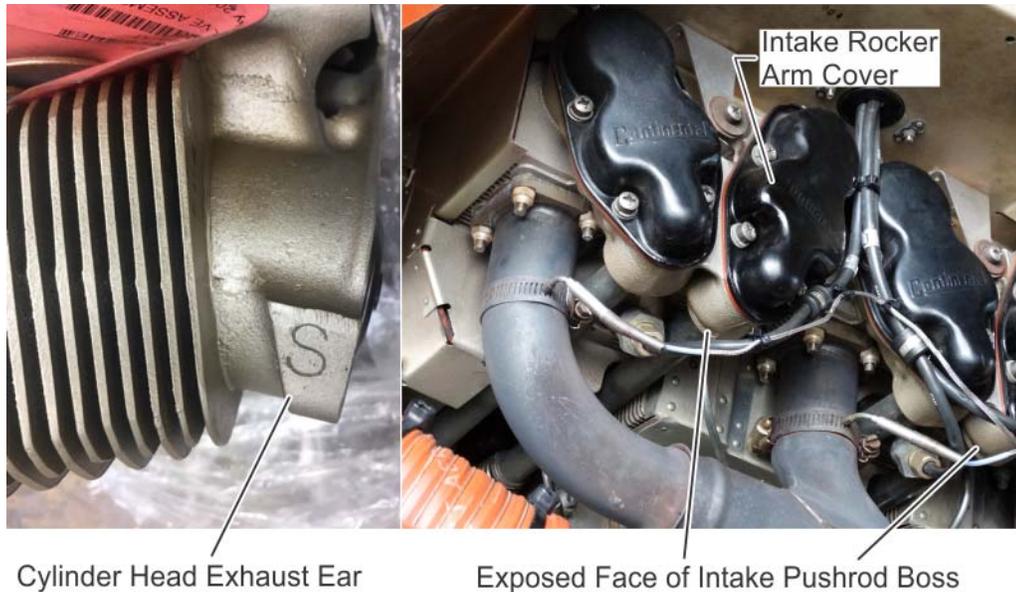
Figure 4. Cylinder Head Indicates Prior Compliance, Stamped with Letter “S”

8. Metal stamp the letter "S" (1/4" stamp) on the face of the intake pushrod boss (reference Figure 4) to indicate service document compliance.
9. Create a logbook entry detailing the compliance action taken in accordance with this Service Document (MSB18-08C). The logbook entry must record all cylinder head serial numbers and include a complete listing of parts used in this installation.

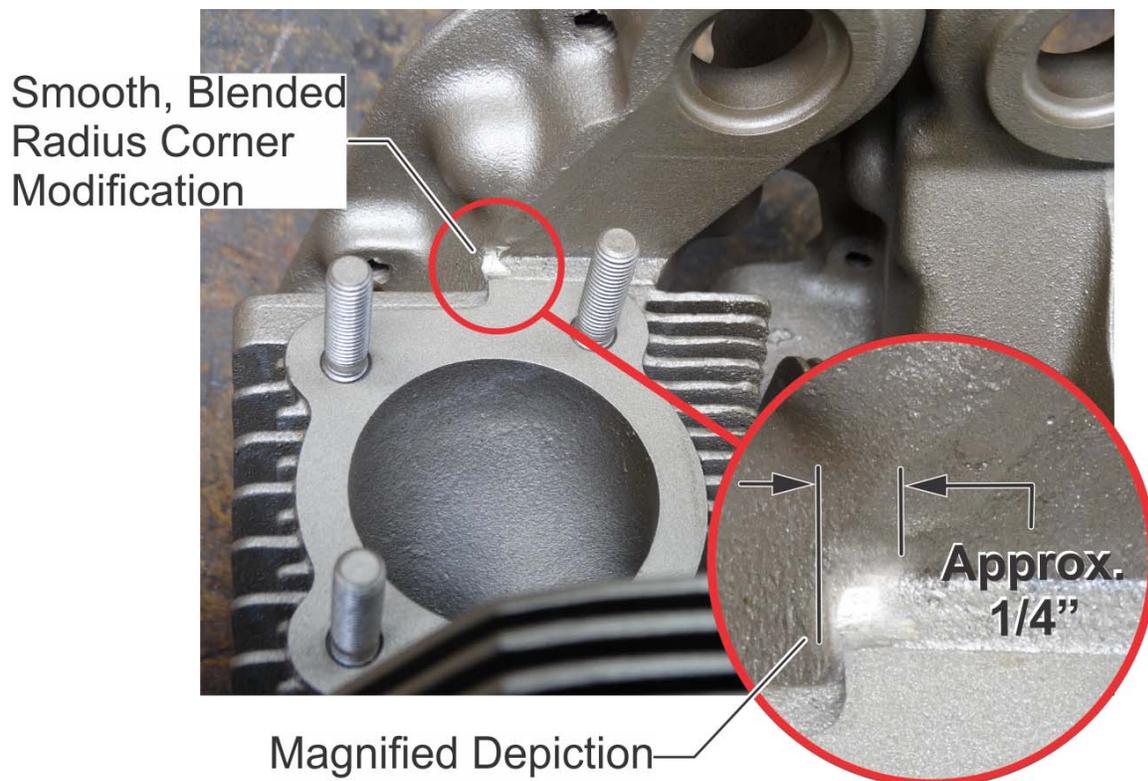
Figure 5. Smooth Radius Corner after Radius Blend Modification

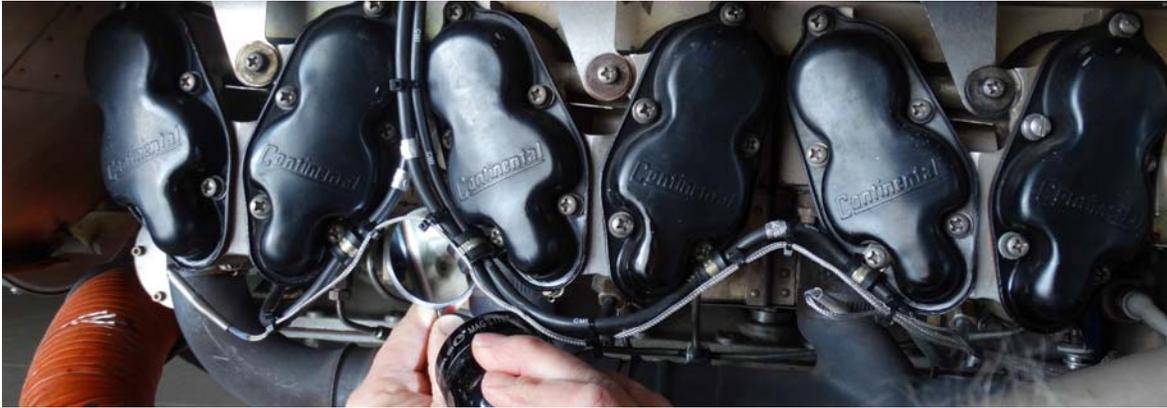
Figure 6. Cylinder Head Inspection Area, typical aircraft installation

2. **RC** Use an inspection mirror to visually inspect the radius corner angle below the exhaust port (see Figure 6) for any casting flash build-up or sharp radius edges. The radius corner should be tapered and blended smooth (reference Figure 5).

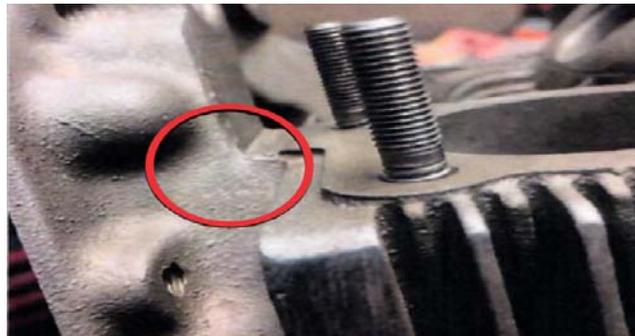
Figure 7. Cylinder Head Radius Corner, side view

3. **RC** Perform a “Non-Destructive Visual Inspection” according to the latest instructions in M-0, Standard Practice Maintenance Manual, Chapter 11, on the area surrounding the cylinder head radius corner (all possible angles). To thoroughly inspect all areas of the cylinder without disassembly, use a magnifying inspection mirror and light source or a borescope with magnification. All cracks require attention, regardless of size or location. If a fissure, crack or physical damage is identified, replace the cylinder.

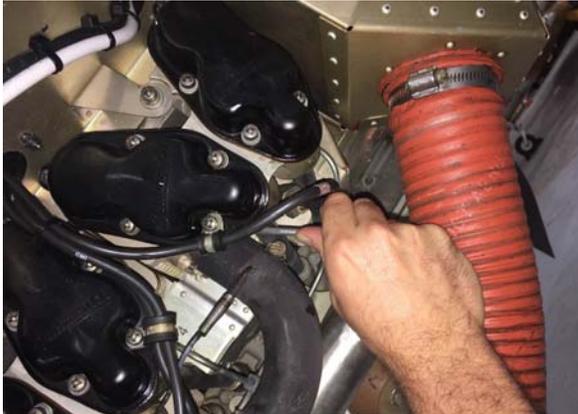
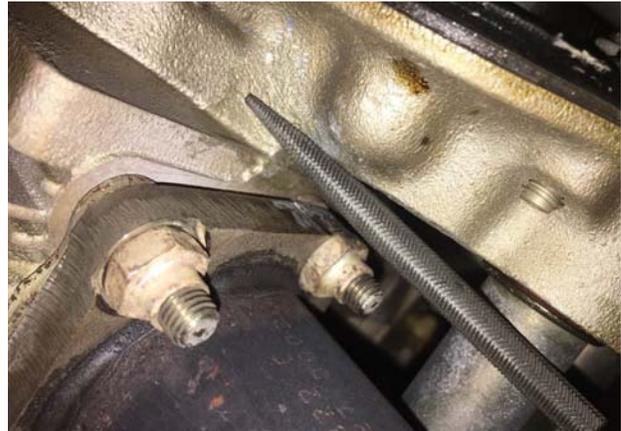
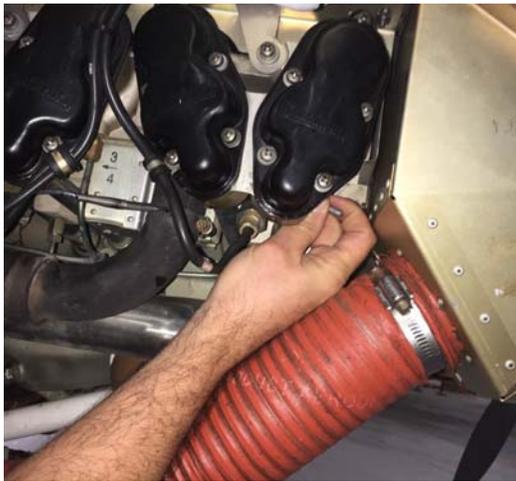
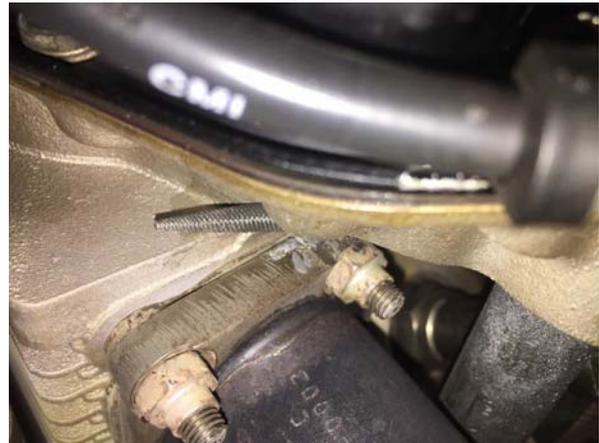
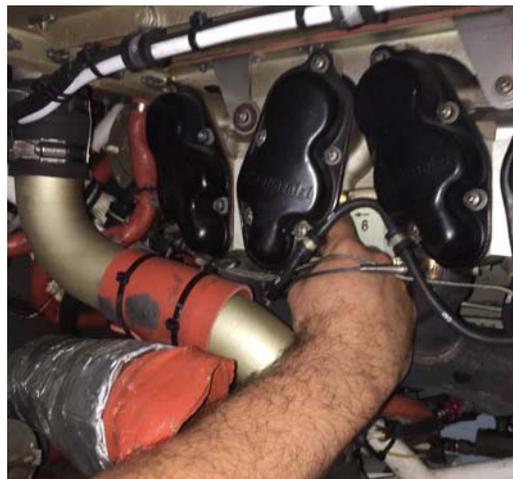
**Figure 9. Reworking Cylinder Head Corner on Aircraft**

*File inserted behind exhaust valve ear, working vertical edge*

*Vertical rework area viewed from front of cylinder*

*File inserted behind intake valve ear, working horizontal edge*

*Horizontal rework area viewed from front of cylinder*

*Hand placement for working horizontal edge*

- a. Carefully, sweep the file around the outside corner to obtain a smooth, blended radius edge.
- b. Remove ONLY enough material from the cylinder head to blend the radius, see Figure 5 and Figure 10. A smooth blend should remove no more than 0.20" material.

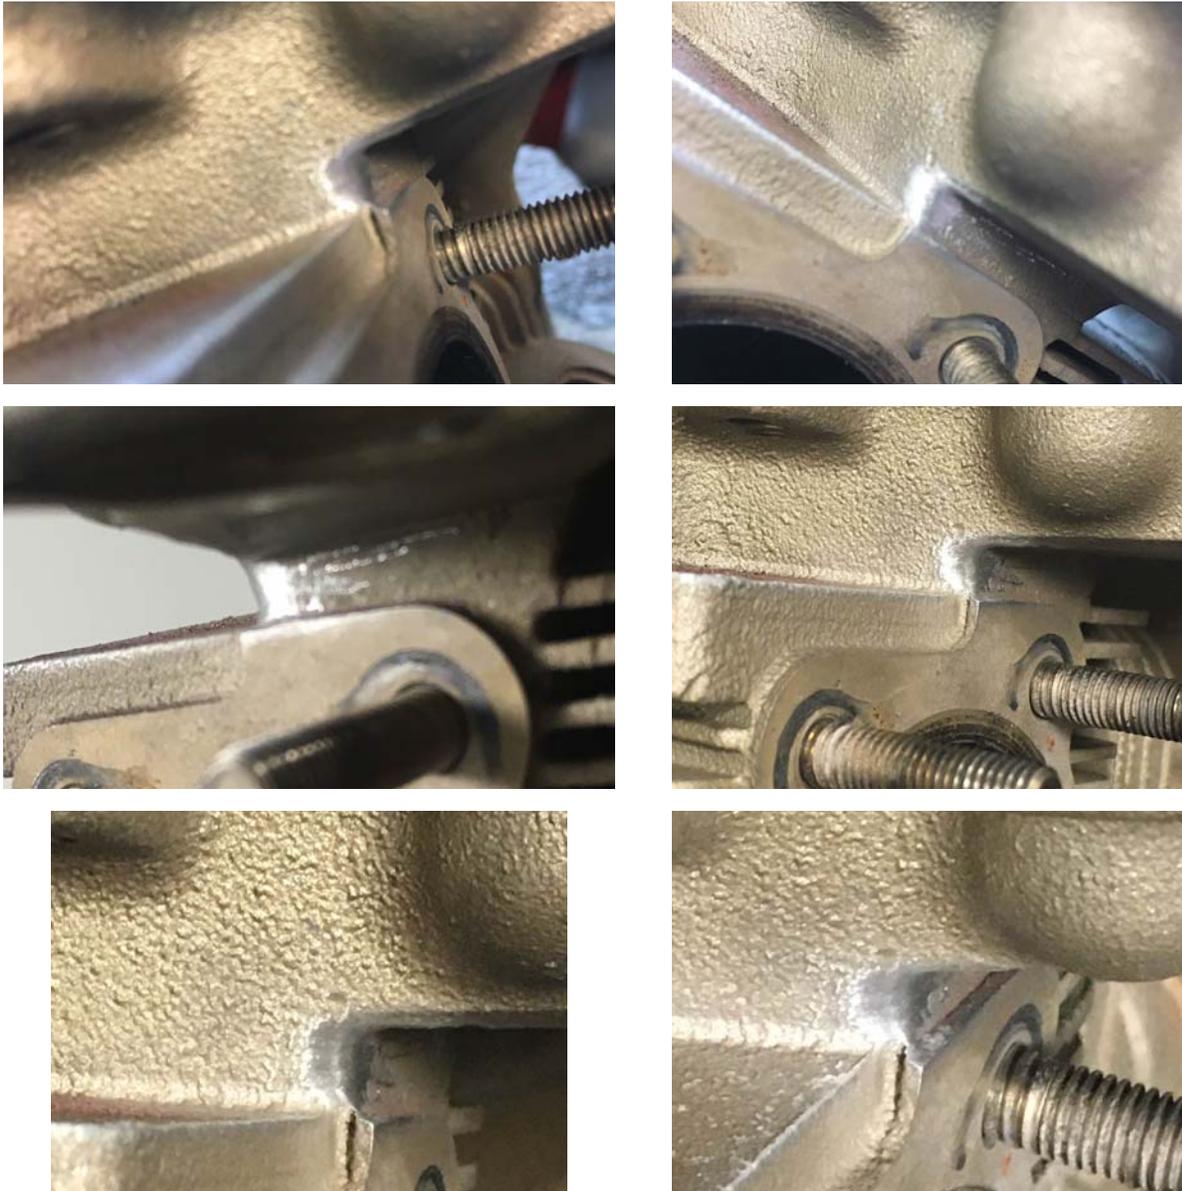
Figure 10. Smoothed Radius Corner after Blending

- c. Photographs in Figure 10 are examples of the smoothing operation correctly executed. The exhaust system and the pushrod tubes are removed for clarity only. Engine disassembly is NOT required to comply with the instructions in this service document.

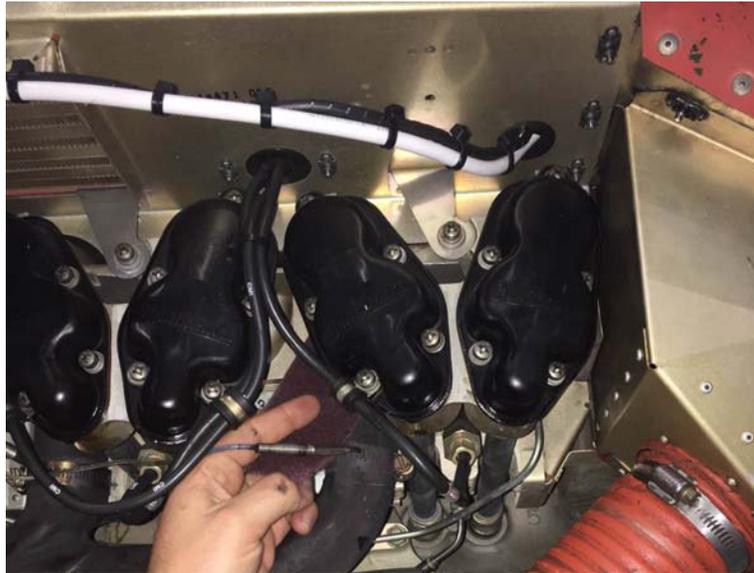
Figure 11. Deburring with Scotch-Brite™ Pad

5. **RC** Inspect the cylinder head surface and remove all nicks, burrs, sharp angles or edges using a de-burring tool and Scotch-Brite™ (ultra fine or equivalent) pad. Evenly shape, taper, and smooth all interfering surfaces where material was removed (see Figure 5).
